PROJECT PROGRESS REPORT

**PREPARED FOR THE ALASKA ENERGY AUTHORITY BY
THE ALASKA CENTER FOR ENERGY AND POWER**

PROJECT TITLE: *Round 1: Emerging Energy Technology Fund— Data Collection*

REPORTING PERIOD: 1st Quarter 2015

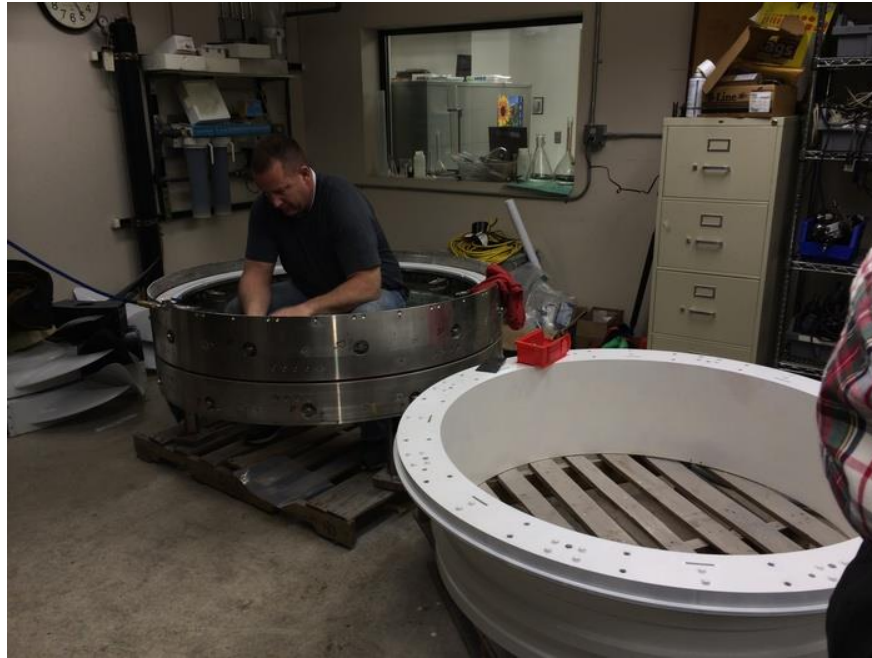
Figure 3: Dismantlement of the Oceana hydrokinetic turbine

Engineers with Oceana Hydrokinetics traveled to Fairbanks in March to dismantle their turbine and assess component wear after last summer's testing in the Tanana River. Inspection of the turbine revealed there was damage to the water-lubricated bearings. During the initial design process, engineers realized these bearings were a place of potential weakness since the waters of the Tanana River have a very high silt load, and they used several types of bearings to test the wear characteristics. ACEP engineers observed that the ceramic bearings were severely worn. The diamond bearings fared

much better. Oceana researchers did not allow pictures of the bearing wear or the inside of the turbine; however, the Figure 3 shows the dismantlement process.
